**August 6, 2010**

## Safety Recall: Shift Cable Socket Holder Is Incorrectly Installed

#### 2010 Element LX 2WD –

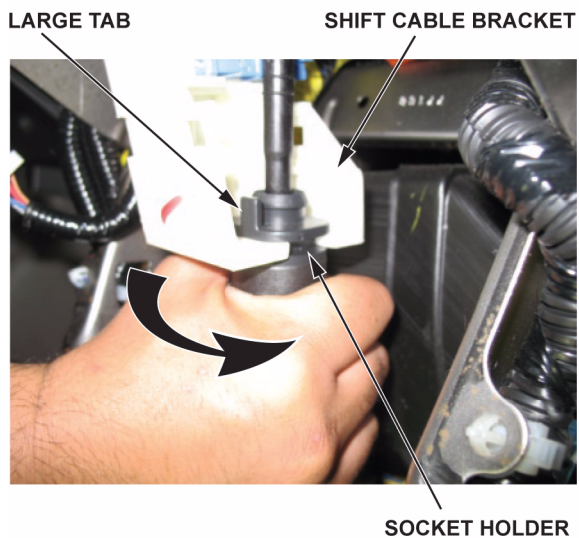
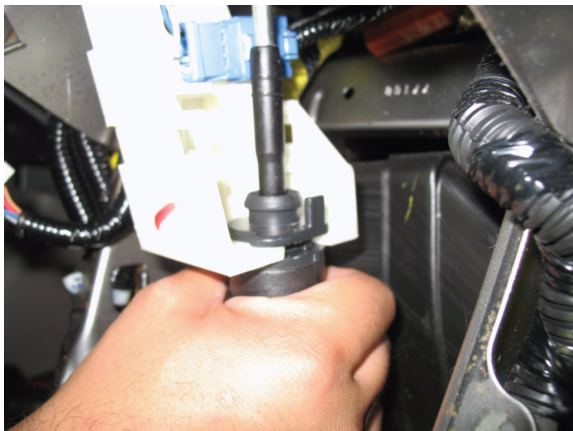
During vehicle assembly, the shift cable socket holder on some vehicles was not properly attached to the shift cable bracket near the shift lever. As a result, the driver may move the shift lever, but the transmission may not be placed in the selected gear. This could cause one or more of these symptoms:

1. *SC models only*: Remove the center console.
2. Remove the dashboard center lower cover.
3. Remove the subwoofer.
4. With your hand on the shift cable socket holder, rotate the socket holder counterclockwise (until its large tab is over the open slot in the shift cable bracket), then remove it from the shift cable bracket.

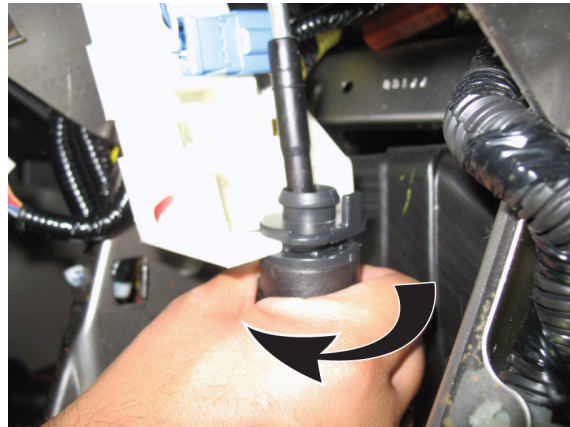
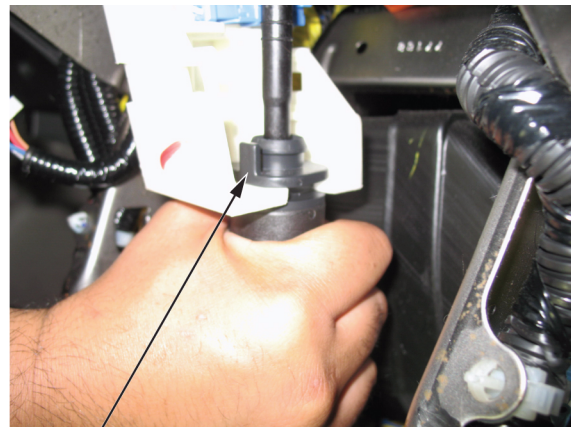
Correct installed position of large tab.

5. Reinsert the socket holder into the shift cable bracket, and rotate the socket holder 1/4 turn clockwise (the large tab moves toward you) to lock it on the bracket. You'll feel a slight bump as the socket holder locks into place.
